Pre-restoration characteristics of upper Willow Creek Granite County Montana.

**Pre-Restoration Characteristics of Upper Willow Creek,
Granite County, Montana**

Michael Sanctuary

December 2002

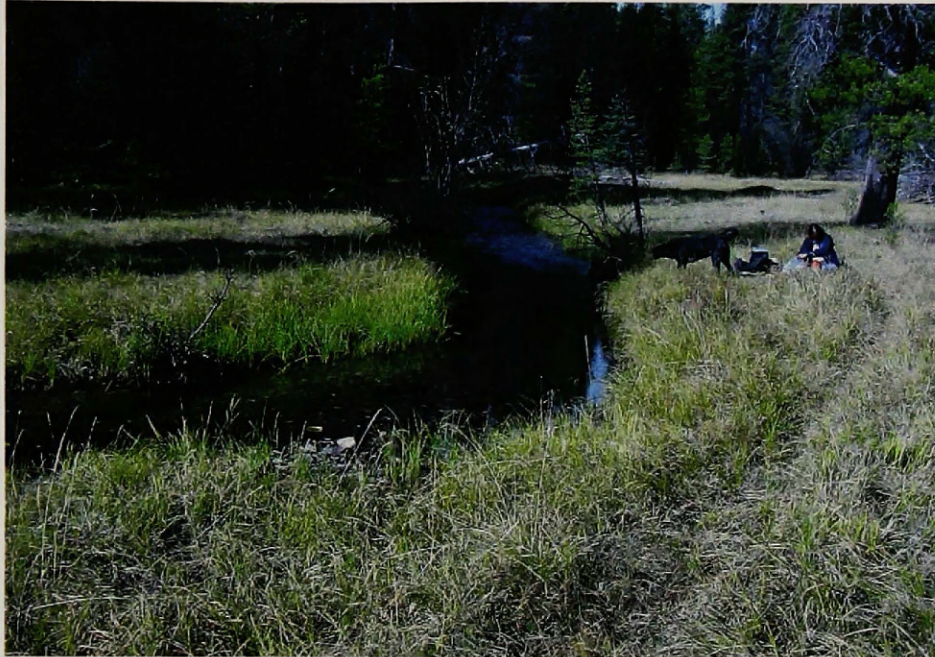
This polygon scored high (89), indicating it is providing most riparian functions at a high level. Vegetative and soil/hydrologic scores suggested good conditions. Grazing pressure on preferred shrubs was light, and only short lengths were trampled and sheared by livestock. Exotic spotted knapweed (*Centaurea biebersteinii*) was present at the downstream boundary where Forest Service Road 88 crosses the creek. The downstream boundary of this polygon was defined by a series of culverts passing under the road.

Figure 13 – Upstream boundary of R1-R4 reach 1 and RWRP Polygon A

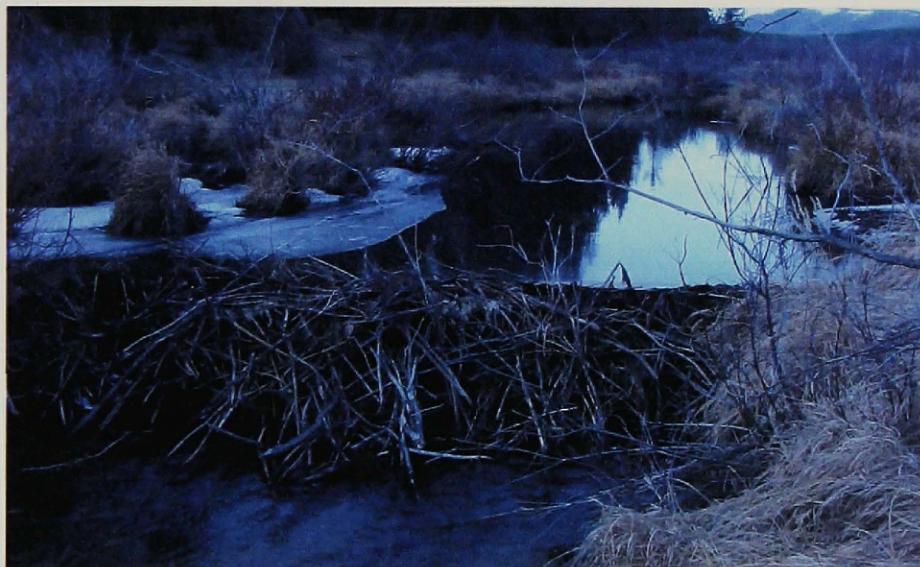
Figure 15 – One of several beaver dams throughout R1-R4 Reach 3

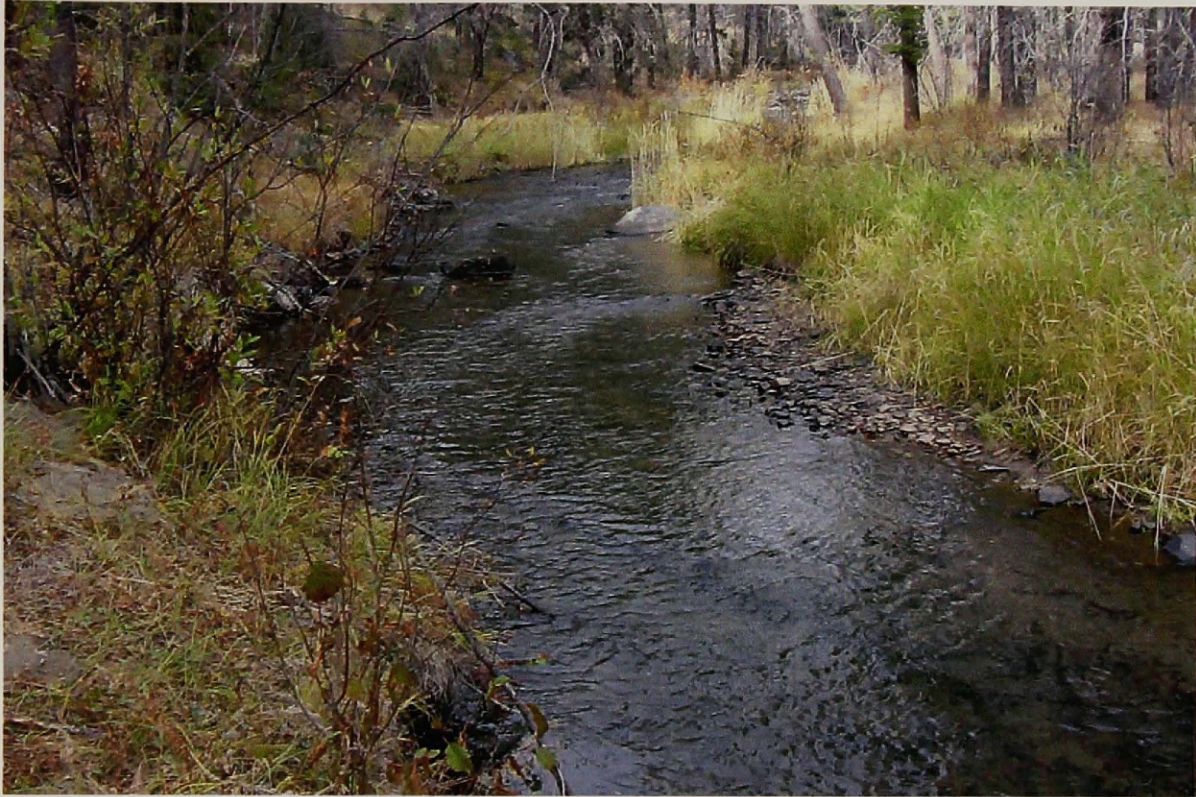
such as Kentucky bluegrass and Canada thistle (*Cirsium arvense*) found in disturbed areas inhabit much of the riparian area. The landowner installed riparian fencing in 2000 (Swanson 2001) and continuously monitors grazing within the riparian area, which may allow eventual recovery. Undercut banks provided good cover for fish, although many of these banks show signs of failure.

Figure 19 – Upper Willow Creek in RWRP Polygon H

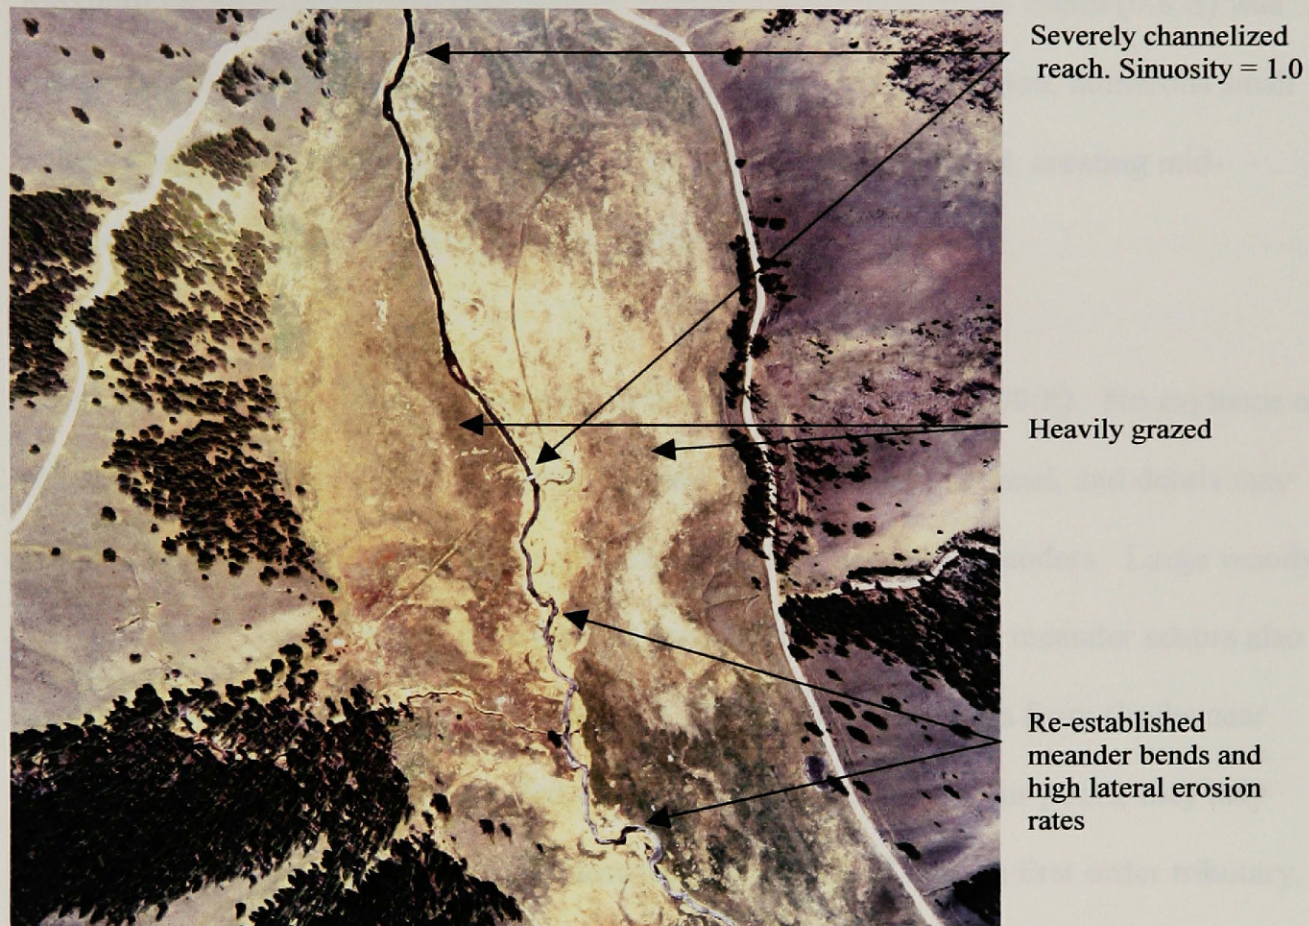
Habitat parameters downstream of the BLM parcel showed very poor conditions and heavy channel and riparian alterations. Percent stable banks (53%), woody composition (12%) and regeneration (20%) were the lowest among all reaches of Upper Willow Creek. Mature, bank-stabilizing shrubs were almost nonexistent within this reach due to extensive willow eradication by herbicide and physical removal. Aerial and ground photographs (Figures 20 and 21) show the majority of the reach was historically channelized, although numerous meanders currently exist as the channel reverts to a natural, more stable sinuosity. Severe lateral scour associated with the reestablishing meander bends resulted in a higher pool composition (53%) than reach 5, which was also severely channelized. Severe scouring created several meander pools, higher pool/riffle ratios in reach 6 and slow-water habitat for fish.

Figure 20 – Aerial Photo of a Portion of Upper Willow Creek R1-R4 Reach 6

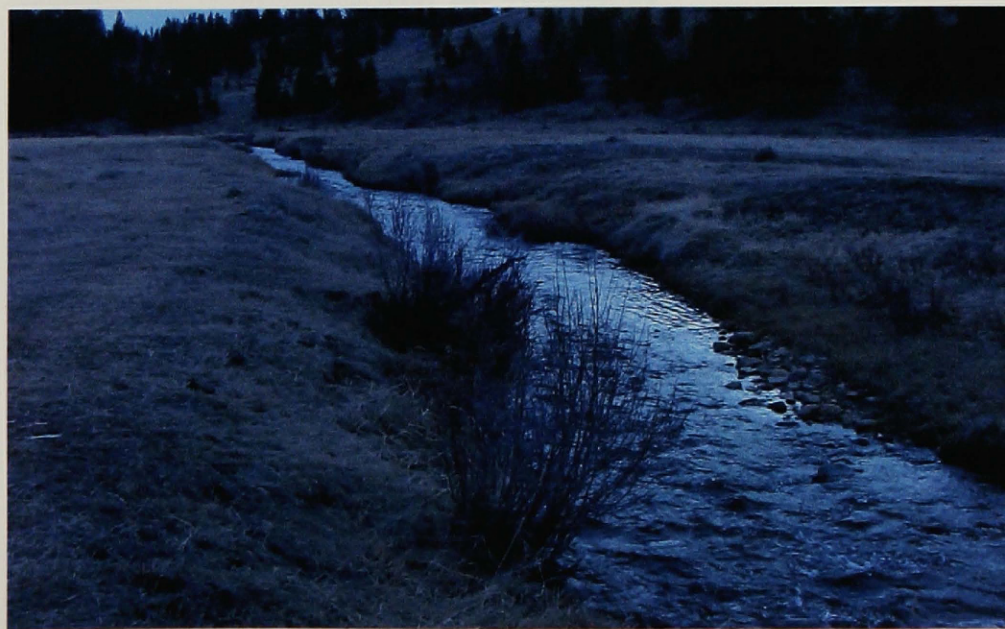
Figure 21 – Channelized Reach in Upper Willow Creek R1-R4 Reach 6

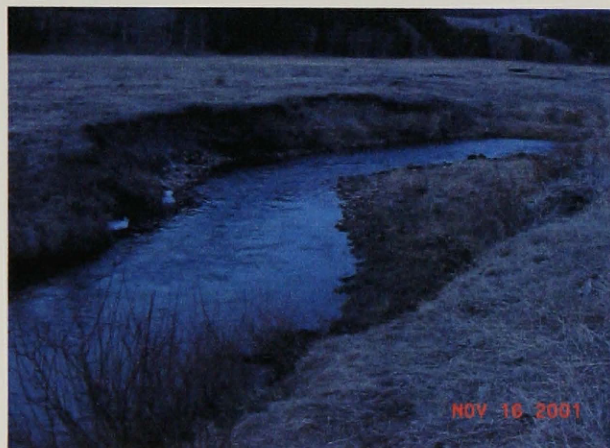
poor vegetative cover of stream banks and several showed unstable characteristics (Figure 22). Lack of overhanging vegetation allowed no thermal protection. Extensive hoof shear, trampling and pugging/hummocking further deteriorated bank conditions (Figure 23). Lateral erosion was evident on virtually every meander bend due to barren banks and lack of binding root mass.

Figure 22 – Severe lateral erosion

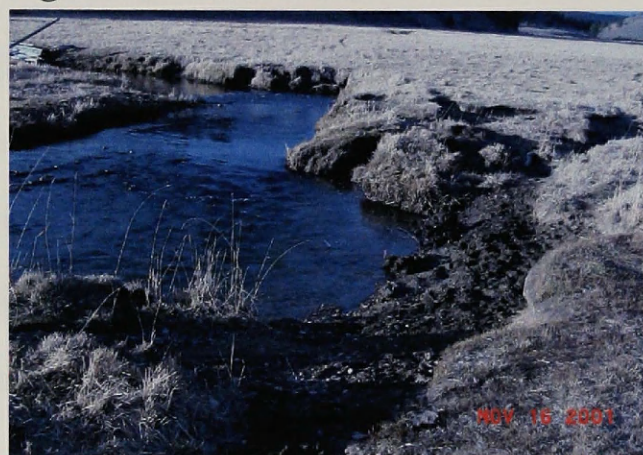
Figure 23 – Hoof shear

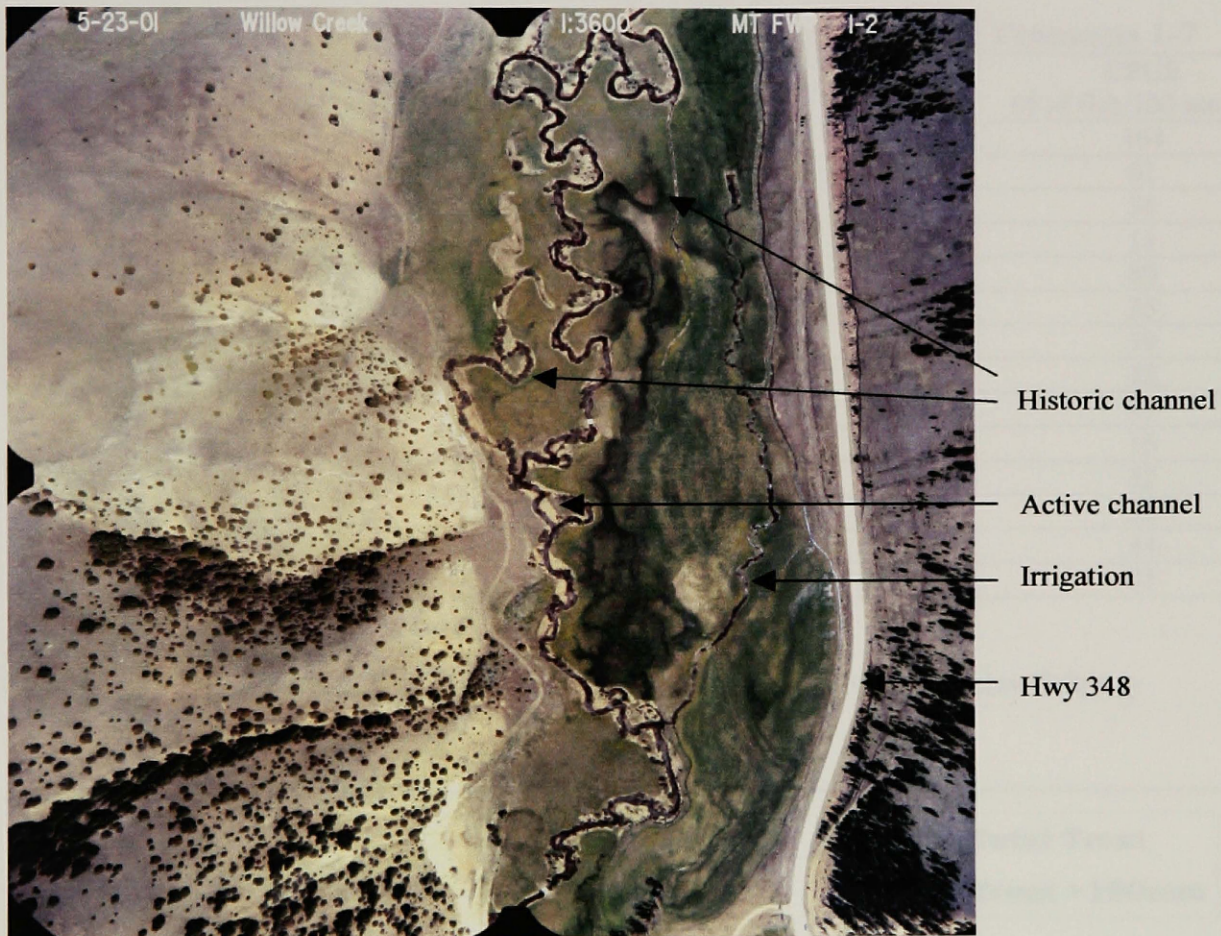
Reach 10 extended 9,627 feet (stream mile 19.5 to stream mile 21.3, bridge just upstream from confluence with Rock Creek) and included RWRP Polygon R. Bank stability (71%) was fair, yet banks associated with numerous meander scours were failing due to poor woody composition (36%). Regeneration improved in this reach (69%) and was the highest in sections II and III. Pool composition was high (63%) and riffle composition remained low (14%) due to a natural sinuosity (1.9) channel pattern. Submerged woody roots and meander scours provided the primary pool formation (61% and 38%, respectively). Pool depths (2.4 ft) and mean water depths (0.8 ft) were adequate for fish.

Figure 25 – Aerial photo of Upper Willow Creek in R1-R4 reach 10 showing natural sinuosity (E4), historical channels, and narrow riparian zone just upstream of the confluence of Rock Creek
